## Muskoka Lakes Golf (MLG)

2018 Water Quality Results: (Note: Hatched cell signifies not tested for in 2018)

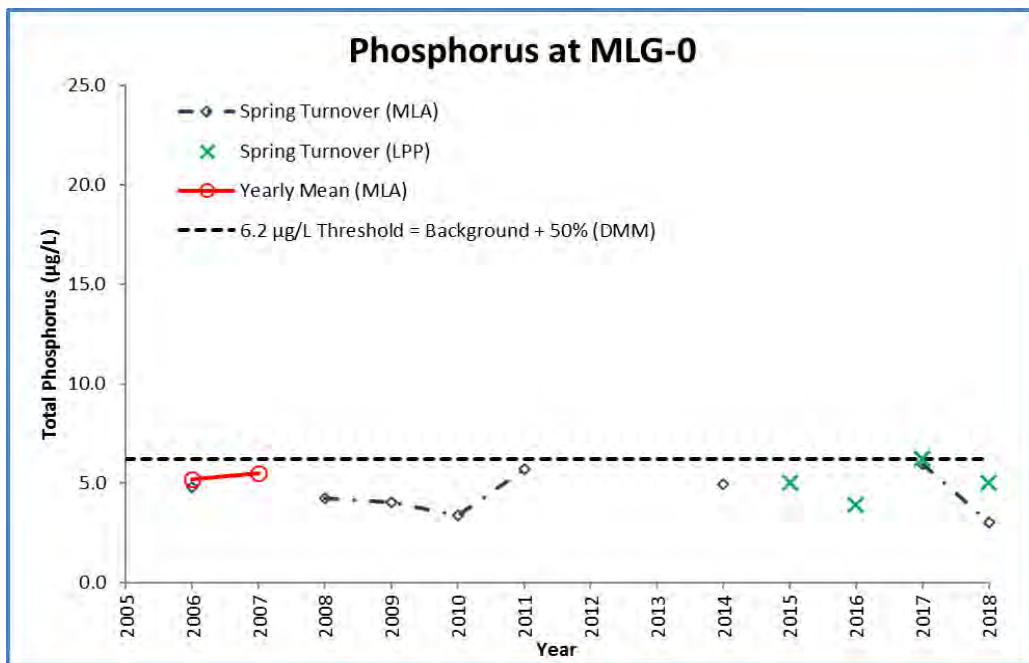
The spring phosphorus concentration at MLG-0 was the lowest recorded to date and was below the historic DMM threshold of 6.2  $\mu\text{g/L}$ . Only one spring phosphorus sample was collected in 2018, therefore no yearly mean could be calculated, and no value is reported for 2018. Lake Partner Program spring phosphorus data was available in 2015, 2016, 2017 and 2018, and is included in the graph. Secchi measurements vary through sampling years, ranging between 3.2 and 5.35. **Beacon recommends that the MLA rely on the Lake Partner Program data when it is available, otherwise the MLA should continue to monitor this location to analyse long-term trends.**
